Exploiting Wi-Fi Stack on Tesla Model S

by Tencent Keen Security Lab

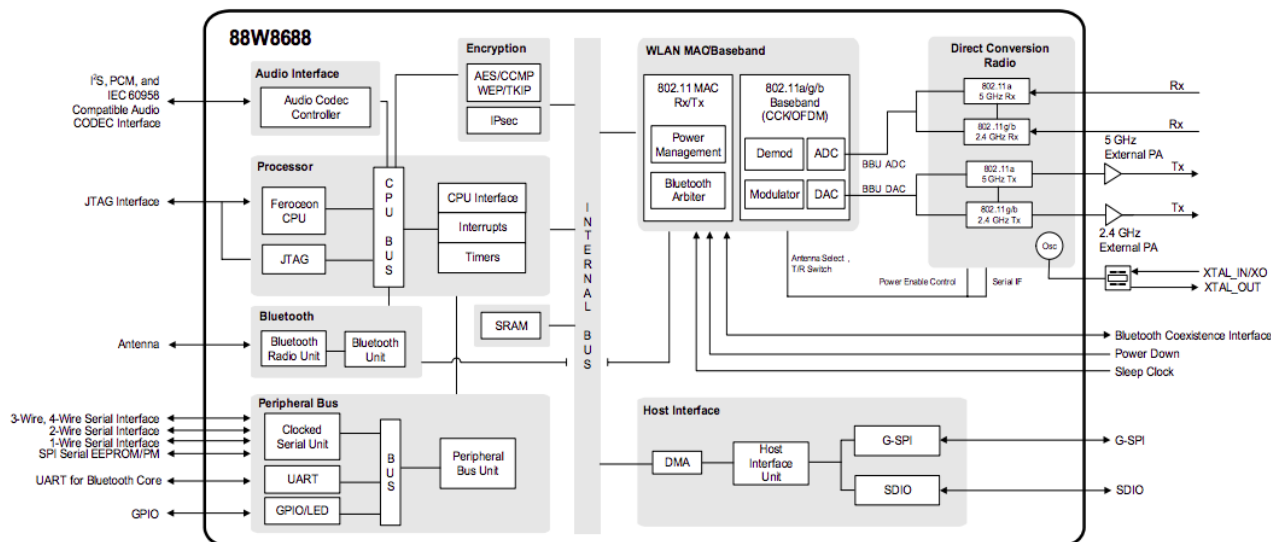
The block diagram published on the Marvell website[3].

The 88w8688 contains an embedded high-performance Marvell Feroceon ARM9-compatible processor. By modifying the firmware, we acquired the value of the Main ID Register, which is 0x11101556. According to the value, we concluded the CPU might be Feroceon 88FR101 rev 1. On Parrot, the Marvell 88w8688 chipset connects to the host system via the SDIO interface.

The Marvell 88W8688 is a low-cost, low-power highly-integrated IEEE 802.11a/g/b MAC/Baseband/RF WLAN and Bluetooth Baseband/RF system-on-chip (SoC) [2].

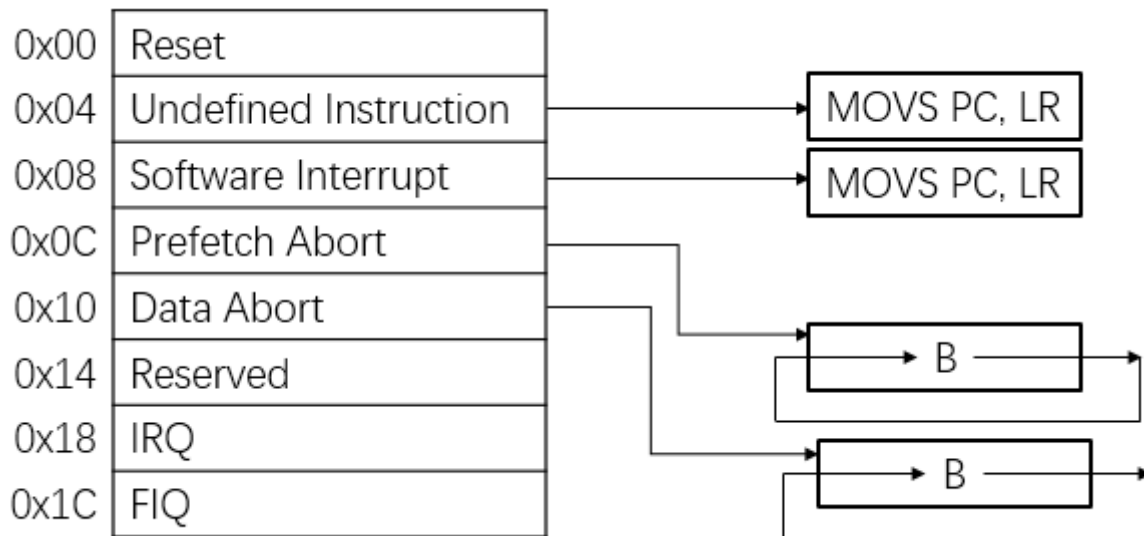
The firmware did not implement the CPU vector handler for Data Abort, Prefetch Abort, Undefined, and SWI, which means the firmware halts after a crash, and we cannot know where and why the firmware crash.

So, we patched the firmware with our custom Prefetch Abort and Data Abort vector handler. The handler records the values of register includes general-purpose register, the status register, and link register in system mode and IRQ mode. In this way, we can know where the code runs in both system mode and IRQ mode when a crash happens.

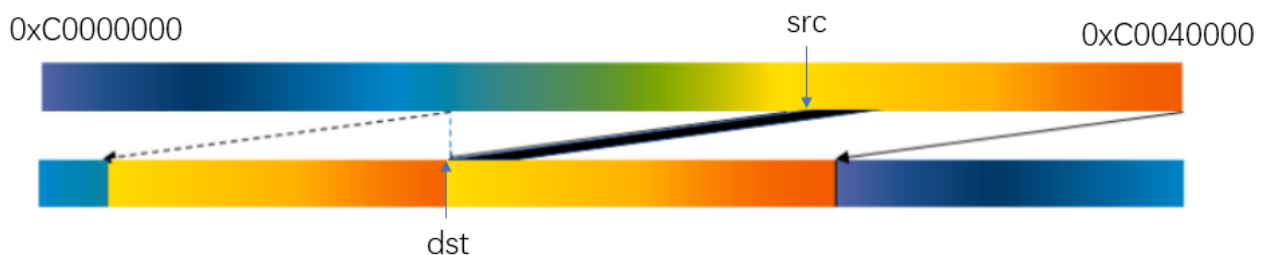
Because the memory region from 0xC0000000 to 0xCFFFFFFF is readable and writable, the process of copying is almost impossible to reach the boundary of the memory region. After 0x40000 bytes copied, the memory can be considered as shifted a distance once. In this process, some data could be overwritten and lost.

The CPU in 88w8688 contains only one core, so the chip may not crash during the execution of copying until an interrupt occurs. Since memory already corrupted by the vulnerability, in most cases, the chip crashed in the interrupt handlers.

0xC0000000~0xC0040000
0xC0040000~0xC0080000
0xC0080000~0xC00C0000
...

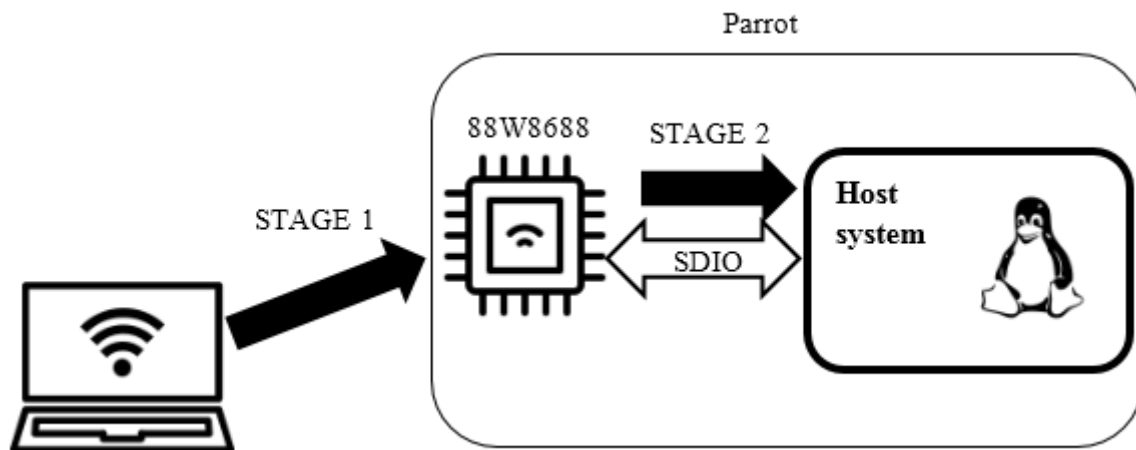
1. The attacker sends DEAUTH frames to all the AP nearby.
2. When Tesla reconnects to AP, the attacker gets the MAC address of Tesla.
3. Spray the fake pointer, then trigger the vulnerability in firmware by directly send corrupt Action Frame.
4. The function `memcpy()` executed until interrupt occurs.

5. Gain code execution in the Wi-Fi chip.
6. Stage 1 shellcode sends the event `EVENT_DISASSOCIATED` to the driver.
7. Stage 1 shellcode handles some commands and waits for the command `HostCmd_CMD_802_11_SNMP_MIB`.
8. Stage 1 shellcode sends the payload to trigger the kernel stack overflow through the SDIO interface.
9. Stage 2 shellcode executed and invoke the kernel function `call_usermodehelper()`.
10. Linux system command executed and try to fix the wireless function of Parrot.
11. Attacker setups an AP and a DHCP server in this AP
12. Linux system command forces the Parrot to join our AP and alter the iptables rules.
13. The attacker can telnet to port 23 on Parrot.
